Western Fire Center, Inc.

**Testing of Exterior Siding in
Accordance with SFM Standard
12-7A-1:
*Fire Resistive Standards for
Exterior Wall Siding and Sheathing***

WFCi Project No. 09079

REPORT DATE: DECEMBER 28, 2009

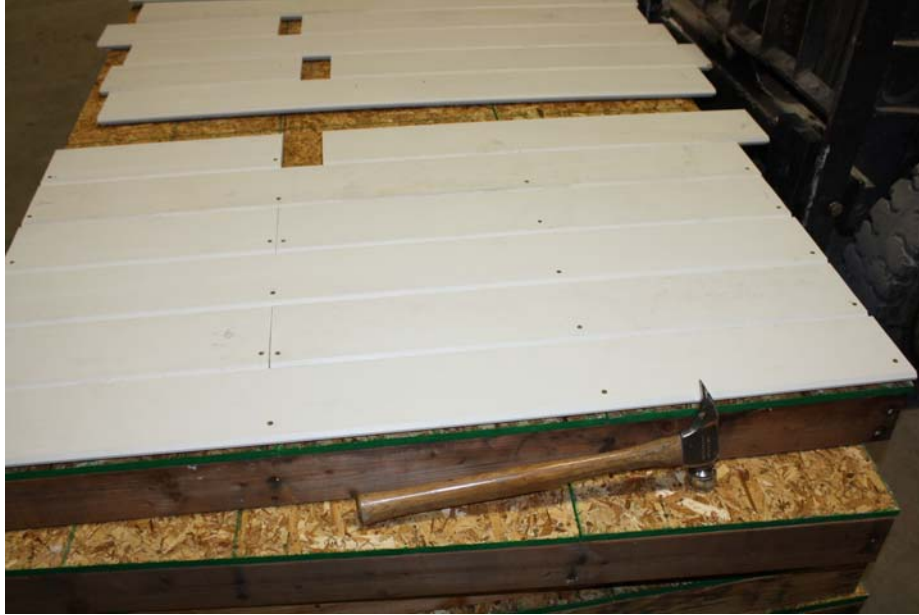
Test 1, Beveled channel under construction

The 4' x 8' wall assemblies clad with solid wood finger-jointed siding were constructed at the WFCi laboratory using test specimens shipped from the client. For these tests, the siding materials were installed **horizontally** over 7/16" oriented strandboard (OSB) sheathing in accordance with client and industry specifications. A butt joint was included in every other course. Wall specimens were prepared in accordance with the test method and manufacturer installation instructions. Building paper was not used.

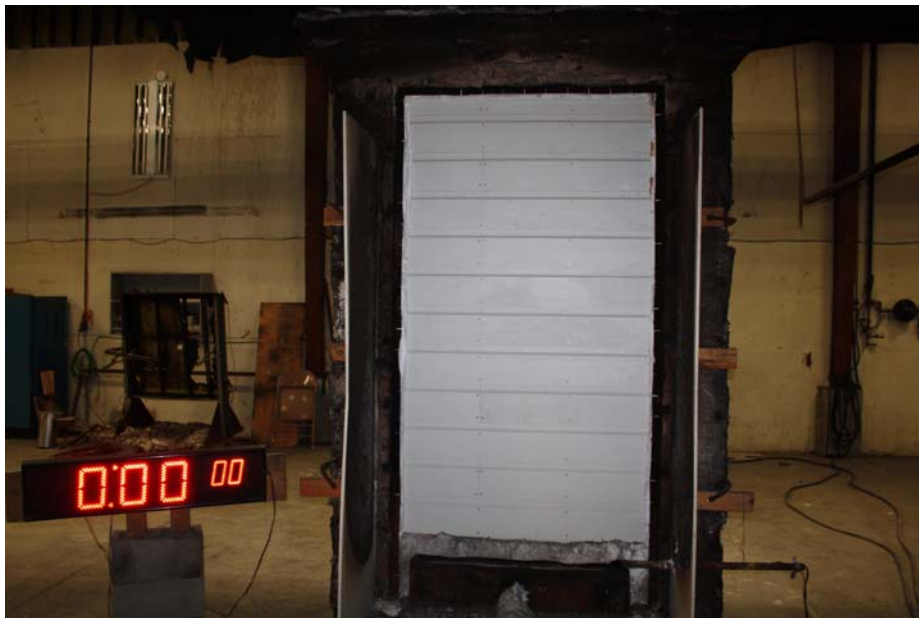
Test 1, prior to test

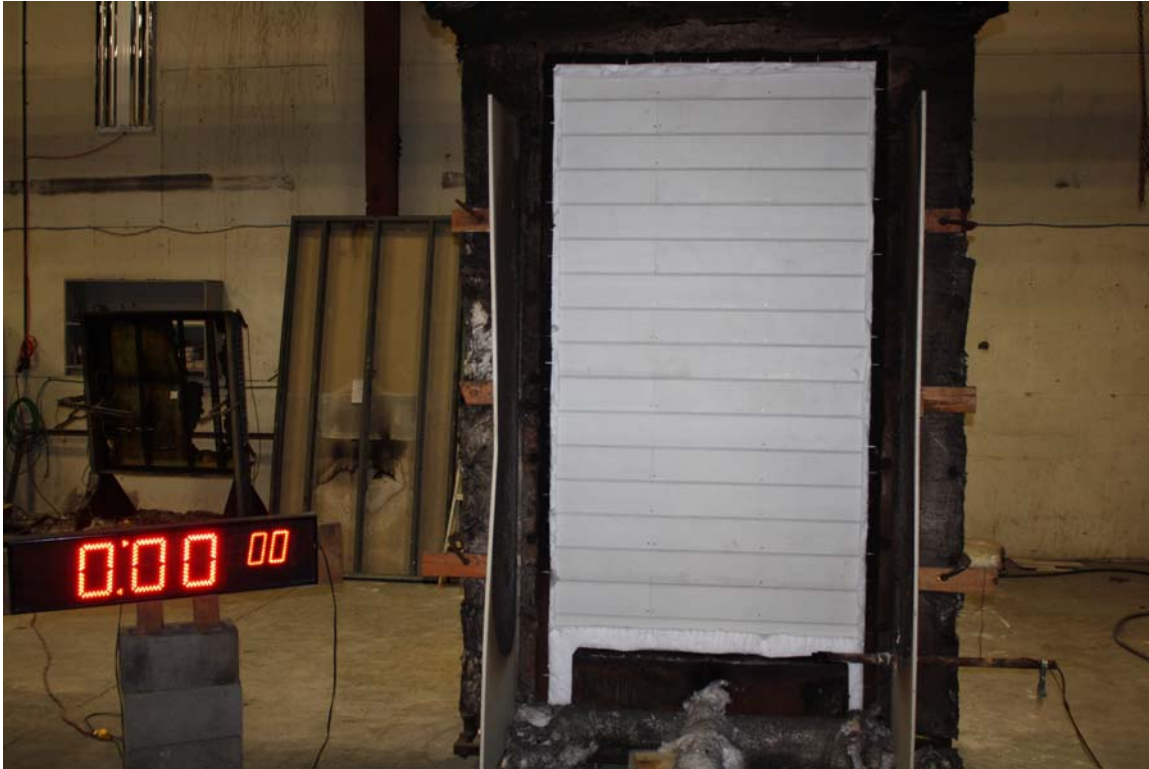
Test 4, v-rustic prior to test

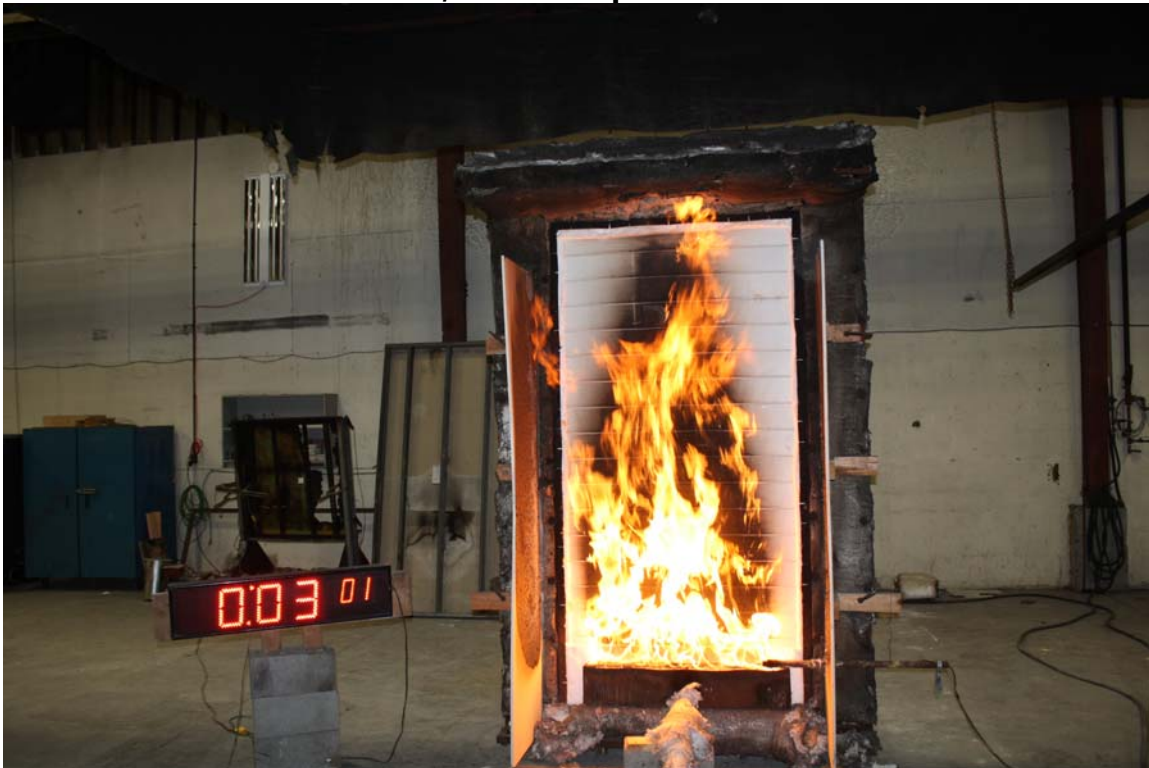
Test 4, v-rustic early in test

Time	Observation
0:00:00	Start Test, Ignite Burner
0:00:31	Ignition face
0:01:00	Flaming to soffit
0:10:00	Burner out- light flaming continues
0:11:45	Flames out, some glowing combustion on face
0:22:00	Glowing ceases, no signs continuing combustion
0:26:00	Temperatures diminishing, Stop test
Post Fire Exposure:	All signs of flaming and/or glowing combustion ceased prior to test termination; no flaming or glowing combustion on unexposed side, test pass
Date	10/21/09
Slot Burner Exposure	150 kW
Laboratory Temp/Humidity	62F / 66%
Sample Moisture Content	Siding 9%, sheathing 6-7%; studs 9%

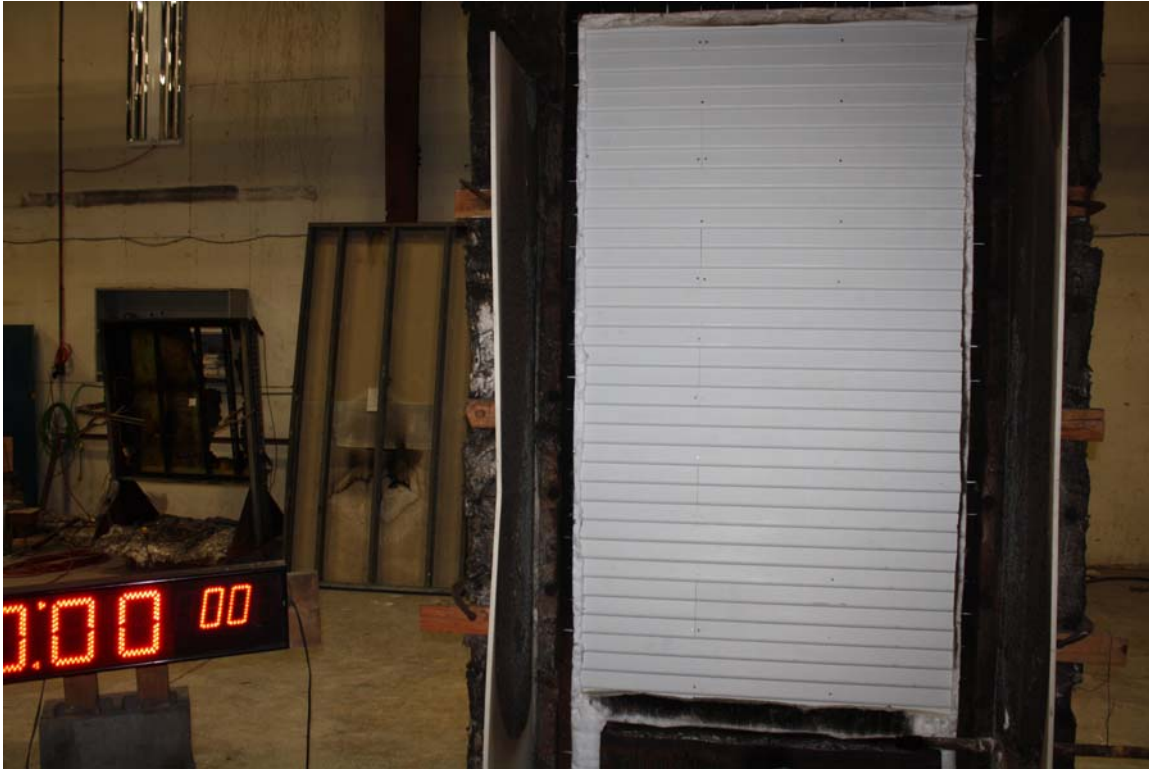
Test 7, 3 lap prior to test
